WHITMAN MIDDLE SCHOOL

# Building Assessment

## Executive Summary

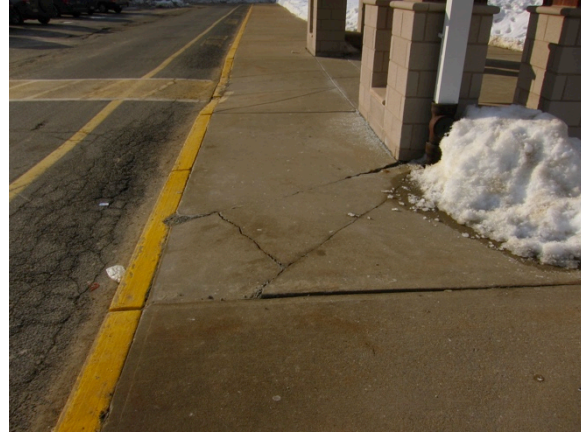
The walkways around the main entrance are in need of repair. There are a number of places where the concrete is experiencing heaves and depressions during the cold weather. The catch basins are most noticeable. There are severe depressions around the catch basins creating tripping hazards. Cracks in the concrete are also noticeable around the campus grounds.

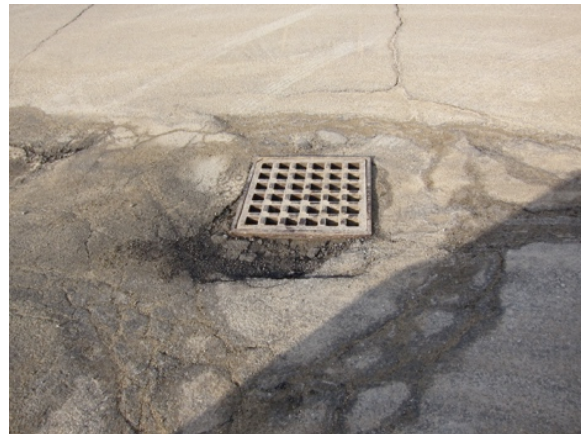
Overall, the parking lot is sufficient in size for the school. There is ample space to support daily activities. There are also spaces to accommodate the town's athletic events, which occur regularly during the spring, summer and fall. The lower teacher's parking area needs to be replaced. As seen in the photo, there are hazards to be addressed. Additionally, most parking areas are in need of repaving.

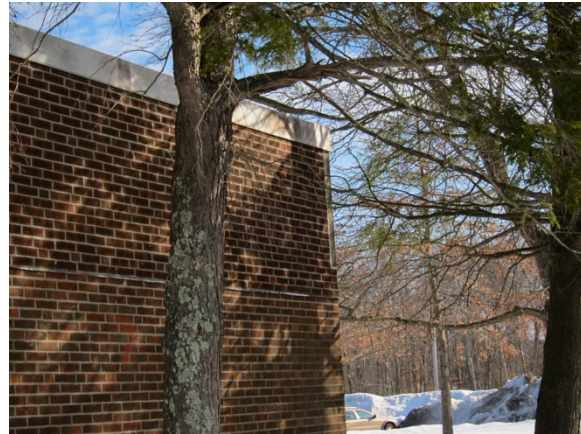
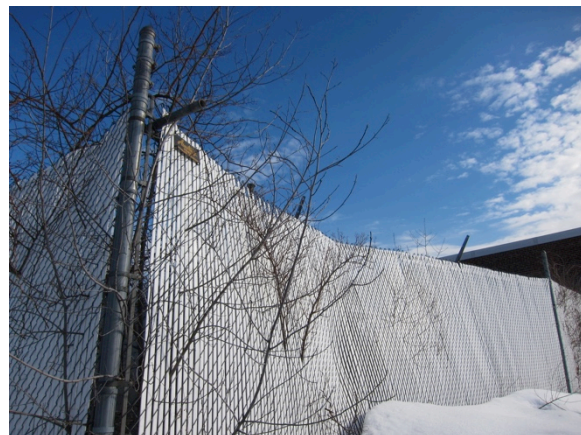
There is a School Resource Officer (SRO) on duty during school hours with an office on site. The SRO identified a few concerns to be noted. The roof has been accessible to potential vandals and small animals. There are two known access points for the roof. The first is a gas main on the west side of the building. The gas main runs from ground level up to approximately two feet below the roof. People are able to scale this main and gain access. The second is vegetation along the south side of the building. People and rodents are able to use the vegetation to gain access. The SRO also noted that security of the student's belongings while attending gym class is poor. The lockers and baskets available to the students are in poor condition and need to be updated. Finally, the SRO identified the age and interior coverage of the camera system as a problem; there have been great improvements in the technology available for this purpose. Conley Elementary, a sister school in the town, is using a more modern system that could be replicated here. The current system is partially black and white and the resolution is insufficient for identification. There are also dead zones in the coverage of common areas.

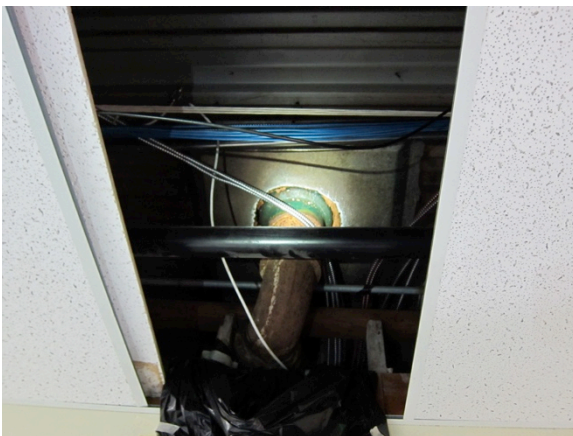
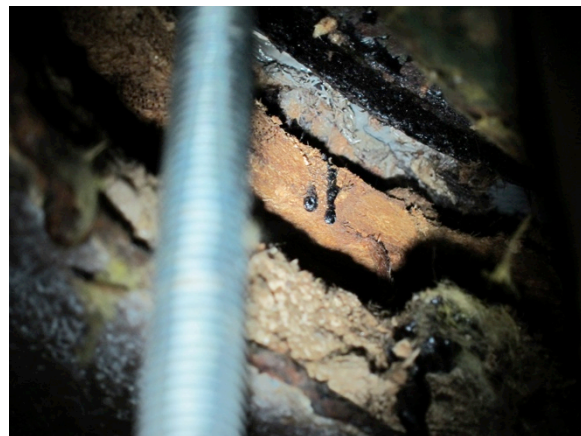
Recently, there have been numerous problems developing with the building's roof. There was a core sample taken from the roof to help identify the multiple layers and test for potential problem sources. Lab testing confirmed decomposition occurring within the layers of roofing material. The most likely source is the fiberboard that

was part of the original roof. Observations made at the penetration points for roof drains and vent stacks indicate significant moisture build up at this layer. One such penetration point showed signs of mold growth. The problems seem to be most severe in the gymnasium.

Inside the gymnasium, particularly during summer months, there is a strong musty odor. Due to the lack of a dropped ceiling in the gym, temperature differences hitting the interior metal deck and the top of the roof are more significant. This differential is conducive to moisture buildup and is most likely accelerating decomposition of the fibrous material in the roof. The moisture is locked inside the structure and causing additional problems for the floor and other surfaces.

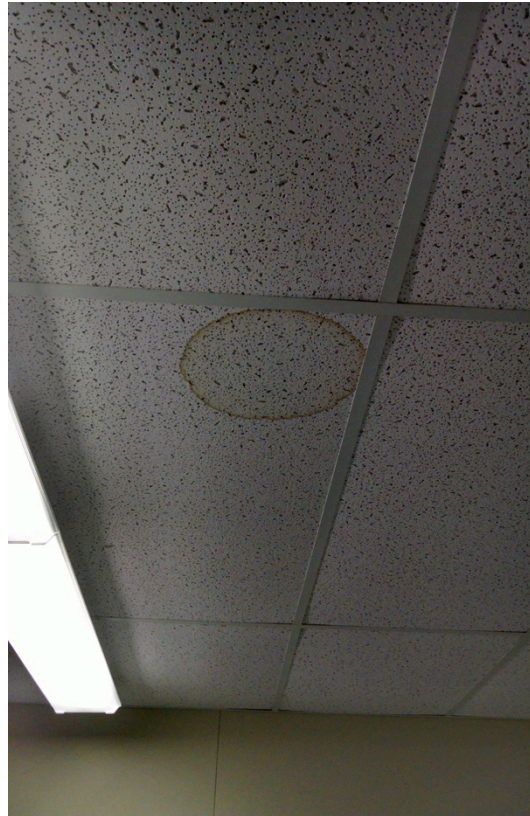
The ceilings throughout the building are mainly 2'x4' acoustical ceiling tile (ACT) in a dropped grid system. The grid system hangs 4' below the deck. There is sufficient space above the ACT for utility usage. Some of the tiles showed clear signs of moisture leaking or condensing above and saturating the material. The items most commonly associated with leaks were the roof drains. Roofing seals around the drains were clearly leaking and creating damage to the interior ceiling materials. Inspection around the roof drain connections revealed more evidence of decomposition of the wood deck at the base of the roofing materials. A moisture meter was used on the exposed wood and it was found to contain more than 30% moisture.

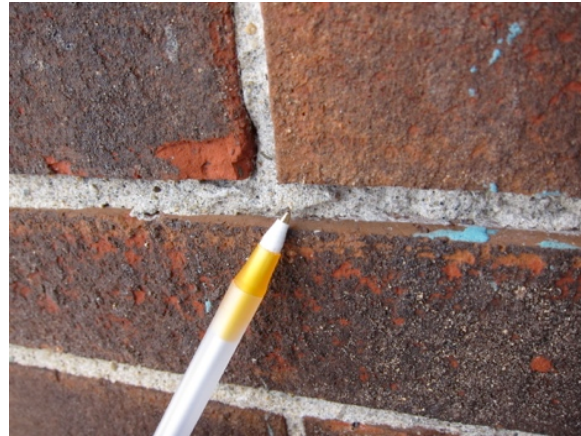
The exterior walls are unpainted brick on a concrete foundation. Most of the building is one floor and there is one main length of construction that is two floors. The 2000 renovation added a portion of the building at the main entry. The condition of masonry work around the addition is good. There were no signs of weathering, cracks, or spalling along the addition. Conditions of the 1972 construction were poor; signs of weathering exist all around.

The original exterior surfaces had cracks, spalling, and stains. The mortar joints around the original construction showed signs of moisture penetration and chunks of the mortar were missing. Moisture has been penetrating the upper level around the cafeteria and damaging interior surfaces. The expansion joint fillings were dried out and separating from the masonry. These joints are no longer weather proof. The concrete foundation surfaces were also spalling with some small cracks and there were larger spots of missing concrete in some places. The penetration points for ventilation had larger gaps forming around the edges and flashing is in need of repair or replacement.

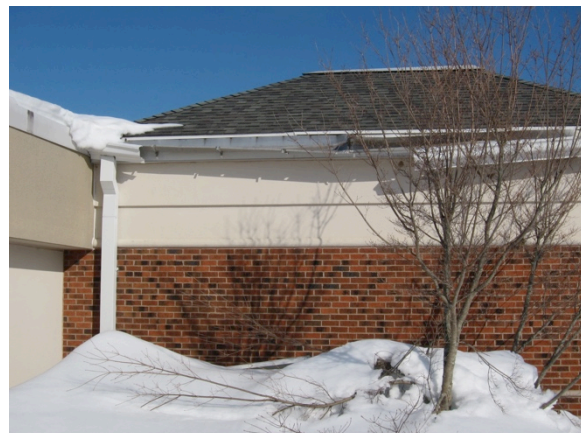
There was some damage found to the gutters and roof flashing around the newer construction near the nurse's office. A section of the gutter has broken and was hanging down from the side of the building. Along that same edge, there was a section of the flashing that was deformed and bent upward. This damage appeared to be the result of some impact. The source was not obvious.

Repointing of masonry and replacement of expansion joints is needed. After the repointing is complete, the surface should be sealed with an appropriate product. There should be repairs made to the concrete foundation, particularly around high use places such as the loading docks behind the kitchen area. Finally, some attention should be given to the vegetation at the southeast corner of the building.

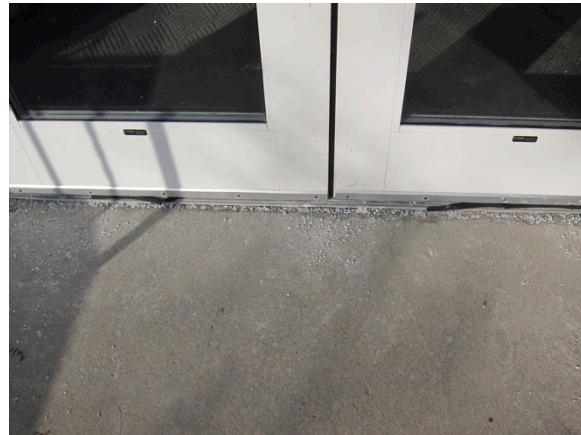
The windows and doors are in overall good condition. All hardware is in place and the windows appear to operate properly. The panic bars on exit doors operate without any apparent problems. The window shades also appear to function properly in most cases. All of these systems were installed during the renovation in 2000. The weather stripping and seals around many of the doors and windows are failing.

Large portions of weather stripping are missing or obviously broken. The most noticeable places are around the entry doors. This problem can also be observed around the windows throughout the building. The obvious ramifications of this problem are loss of heating efficiency. The selected glass for all windows has a U-Value of .58; the thermal transmittance for windows in this region should be lower than the selected product. The local climate is better suited for a U-Value between .17 and .39. Replacement of the windows and doors would provide a reduction in heating costs. The window shades offer some protection from solar heat gain during the warmer months.

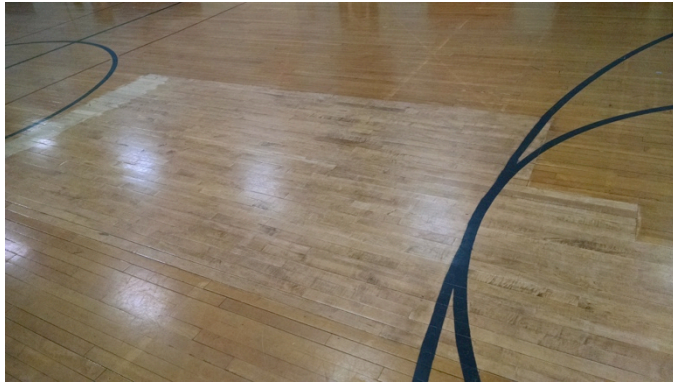
The school has already targeted the gymnasium as an area for improvement. Due to the construction methods used in repairing the roof, the gym has a very high moisture level, which is detrimental to the maple floorboards in the gym.

We used a meter to measure the amount of moisture in the floorboards. The measurement was 11%, which indicates between 60 and 75 percent humidity. The elevated humidity is causing the boards to swell and create the noticeable heaves along the gym floor. The humidity is also conducive to mold growth in the gymnasium. The indoor humidity should be maintained at 30 to 60 percent in order to reduce the possibility of mold growth. The musty odors noted earlier in this report are indicative of the moisture and mold. The gym floor has already undergone some repair and patchwork due to moisture damage. There are evident 'dead-spots' where the floor does not have any bounce, which means the floor no longer functions properly. Dead spots in the floor are caused by the collapse of sleepers underneath the top layer of floorboards. Given the current conditions, the floor no longer meets the requirements for local sporting leagues. If repairs are not made, sporting events will likely be moved to other locations. A final observation in the gym is the condition of the bleachers. A previous engineering survey has identified problems with the bleachers that are out of safety codes for such equipment. Overall, renovations in the gymnasium should be significant.

**Appendix 3** is a potential product for consideration as replacement for the flooring; the product is one of many suitable replacements.

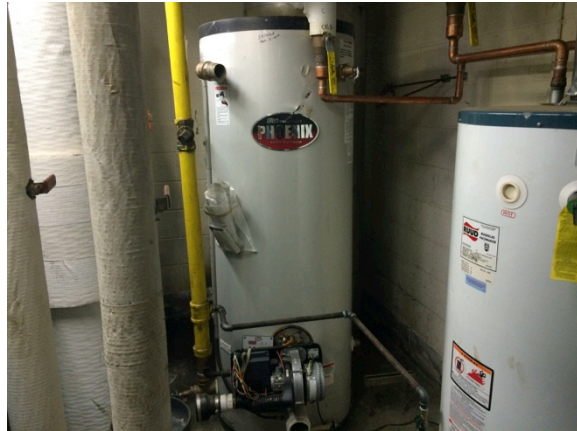
The water heater is a 75-gallon gas-burning model. The system has an 80 percent thermal efficiency. This system was manufactured in 2008 and put in place as a temporary fix when a larger system began to fail. A permanent solution should be put in place as soon as possible.

The amount of hot water required at any given time is achievable with a tank-less water heating system. The flow rate could be achieved by placing two to three units in succession. From an efficiency perspective, selecting a tank-less gas water heating system would be a good long-term solution. If not incentivized, this type of system would not have a good ROI; there is an \$800 incentive available to Massachusetts' gas utility customers, which may offset a considerable portion of the cost. If utilized, the incentive would make the upgrade well worth the investment. At this time the incentive is good for systems put into use during the 2015 calendar year. If this option should be pursued, the system selected must satisfy a >.94 energy factor rating on the electronic control components.

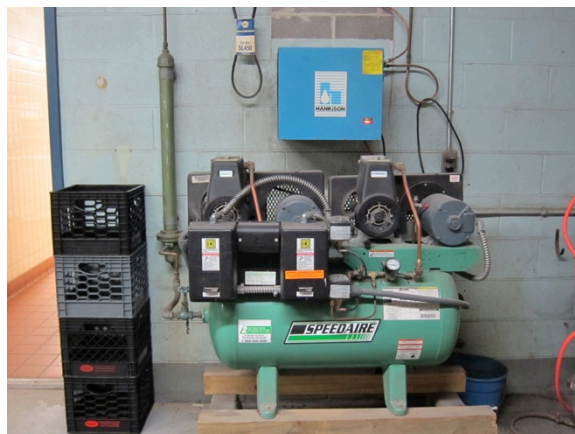
The building is currently using a pneumatic system to communicate commands from the controllers (thermostats) to the cabinet heaters located throughout the facility. There is a single source of compressed air located adjacent to the boiler room and near the backup power generator.

The two compressor motors work alternately and can be observed running more frequently than designed for; the persistent running is indicative of leakage in the pneumatic lines. This system should be at rest 10 out of 30 minutes. The system is achieving half of the specified down time.

Today, most of these systems are being replaced by direct digital control systems. The pneumatic controllers are able to operate in harsh conditions, but they require regular maintenance in order to stay within calibration limits. The down side to converting is the cost associated with installing digital thermostats and circuits to support the new equipment.

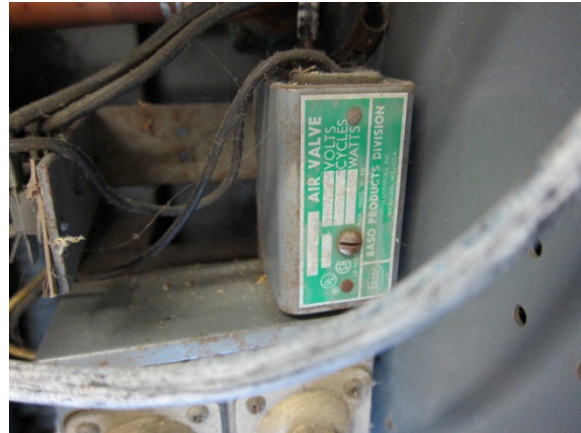
The cabinet heaters and pneumatic controls have been a persistent source of trouble in the building. Work requests related to the system have become routine and the cost of labor associated with repairs has been increasing over recent years. Additionally, the parts needed for repairs of the pneumatic system are quickly becoming more difficult to find; these components are not generally produced today.

During the next planned renovation of the facility, both the controllers and the heating cabinets should be scheduled for replacement. The new equipment would reduce maintenance costs and provide more dependable heating throughout the facility. When this conversion takes place, consideration should be given to placement of the new circuits. The new circuits should be designed to fail in the open position allowing the heat to remain on in the event of power loss. Additionally, the controllers will require a transformer to reduce the 120-volt house system to the lower voltage digital systems.

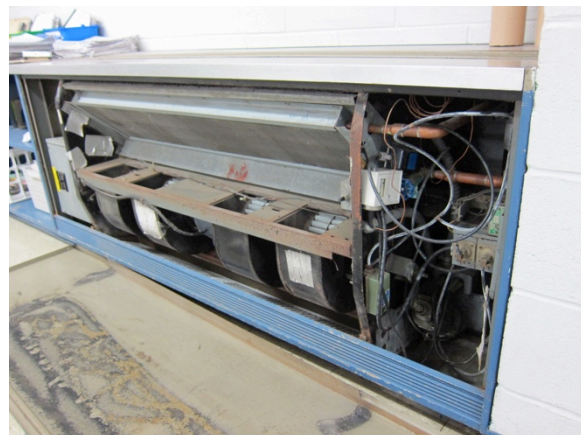
The Cabinet Unit Heaters are Nesbitt Aire syncretizers. The units were part of the original construction. These units have outlived their expected useful life. There have been routine trouble calls associated with these units across the facility. Reactive maintenance costs associated with these units are accounting for increasing portions of

the facility's budget. In addition to the reactive maintenance costs, the pneumatic controls are subject to persistent air leaks, which have lead to constant running of the electric motors. The wasted energy is surely costing the school district more money than the replacement costs over time. The units could easily be replaced by updated equipment that is readily available from the same manufacturing company.

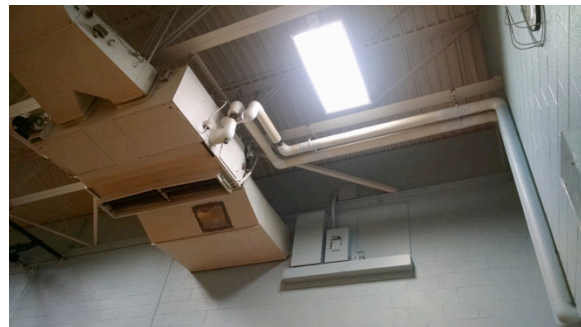
The large air handlers, located in the gym and the smaller exercise room, appear to be in fair condition. We had limited access to the roof during our assessment due to the snow and further inspection of the air intakes on the roof should be completed.

Both air handlers do suffer from small dents in their piping and ductwork. Although much of this is negligible, larger dents may cause issues with airflow in the ducts and water flow in the pipes. Any dent significant enough to impact the efficiency of the air handler should be repaired. The air handler in the gym may also be working harder to maintain occupant comfort, given the high levels of humidity in the gymnasium. A dehumidification system should be installed to reduce the moisture and associated problems that exist in the gymnasium.

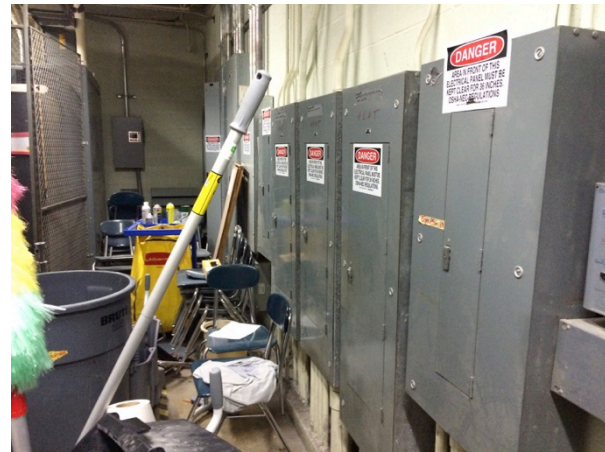
The electrical rooms are original to the construction of the building in 1972. It did not see renovations during the 2000 remodel. The panels are old but do not appear to be rusted or corroded. There are older panels in each of the electrical rooms that are not used anymore but have been left in place. There are also miscellaneous items restricting access to the panels in both electrical rooms.

The electrical room adjacent to the elevator seems to be used more for storage than it is for housing the electrical panels. This practice poses safety and fire hazards. The stored items are mostly combustible and add to the fire load of the room. If a fire were to occur, the items would accelerate its growth and spread. The second issue with all of the stored items is access to the panels. Access to the panels is critical during an emergency; there should be nothing hindering access when the electricity needs to be cut off. The final safety issue found in the electrical rooms is missing fire-stop to seal off the room from all other areas. There are gaps at the point where the wall meets the roof deck. There are also missing seals around

conduit penetrations through the walls in some places. These issues are code violations per **Appendix 5** and should be addressed as soon as possible.

Our recommendations are: remove any panels that are not in service, create appropriate storage for items required on campus, and examine all walls and barriers for appropriate fire prevention measures. After reviewing the space usage throughout the facility, there is clearly a need for additional storage capacity. A permanent or moveable storage locker would be appropriate for the school. There are many options for these types of containers. An

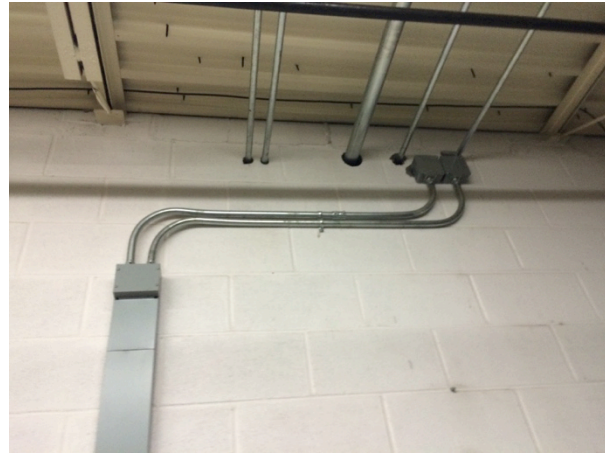
appropriately watertight system may be suitable for storing the file cabinets and other items consuming space inside the building. The fire-stop was found to be in the planned scope of work during the last renovation, but it was only partially completed in the electrical room by the elevator. There is no fire-stop in the electrical room by the boiler.

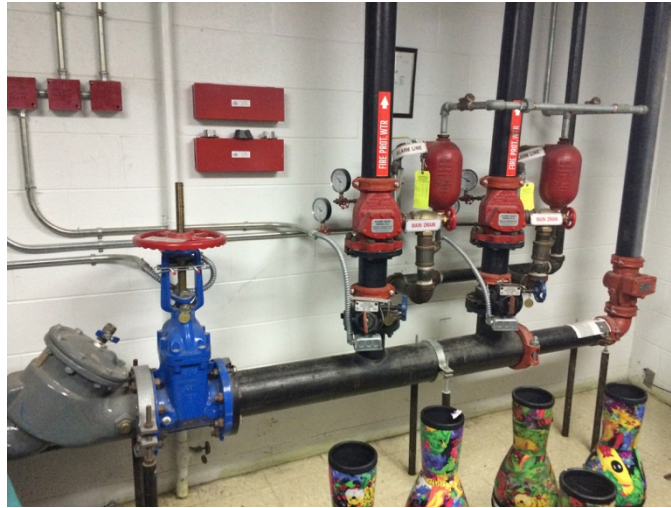
All sprinkler heads are free and clear of any obstruction; there were no signs of leaking. There is no mold build up on any of the heads. The standpipes and fire department pre-connects were free and clear of any obstructions allowing quick tie in for the fire department. The couplings did not seem to be rusted or damaged. The room where the water supply connected to the sprinkler system had some clutter in it; the room seemed to be used as

a storage area for some musical equipment. Our recommendation is to have the musical equipment and all other clutter removed. There should be nothing obstructing the path of fire department officials in an emergency situation.

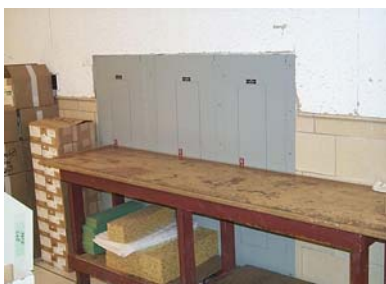
Figure 1: Blocked Electrical Panel

Electrical panels contain multiple junctions of live wires and other components, and they are required to be accessible at all times. Panels are also required to have a “dead front,” per 29 CFR 1910.305(d). NFPA 70 describes a dead front as an area of the panel “without live parts exposed to a person on the operating side of the equipment.” All live components must be covered in

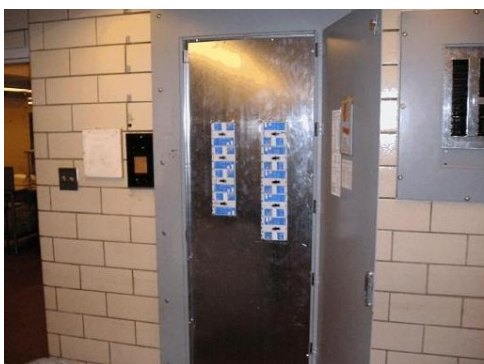
Figure 2b: Same electrical panel after abatement. This panel now has a “dead front.”

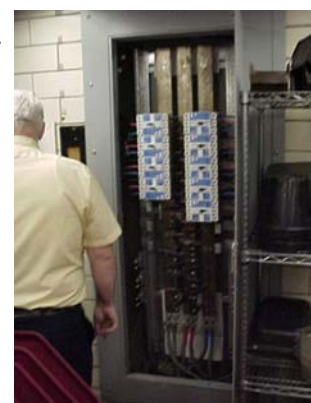
Figure 2a: Electrical panel with missing dead front
